### [CODE100] P.S pressure high / T.S Temperature high

### [CODE603] F.W Temp High

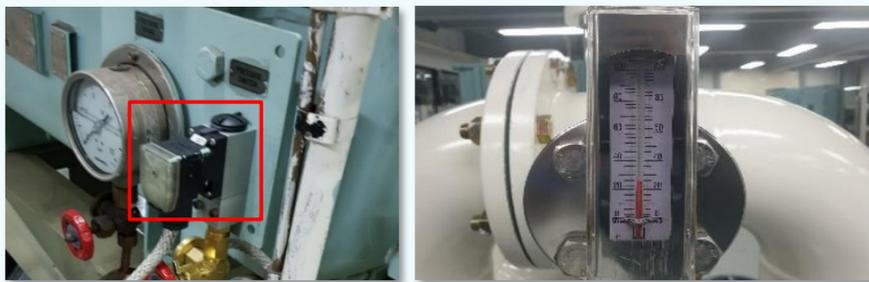
By measuring the temperature and pressure of the ECS, if they exceed the reference values, the system operation will be shut down to prevent safety issues. However, if the shutdown is due to a different issue rather than an actual temperature/pressure problem, it may cause inconvenience to the user. Therefore, please diagnose and resolve the issue using the following methods.

1. Check the pressure and temperature by Pressure & Temperature Indicator. (Press' : below 4.5 bar, Temp : below 45°C )

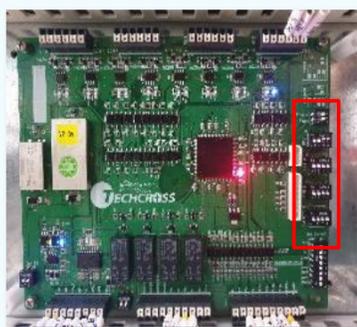
4. In case of the resistance of P.S or T.S is "O.L.", ESJ signal board is defective and swap test with normal ESJ signal board is required.

- 5. Open ESJ and check signal board.
  - 5-1. Non-ex ECU : ESJ is installed at ECU.
  - 5-2. EX-ECU : ESJ is installed at Safety zone.

6. Carry out the swap test with normal ESJ Board. (Dip switch setting (red box) shall also be swapped.)
